Vehicle Applications for Remy Part 92570

Remy Upgrade Helps Solve 6.0L Ford Low Voltage Concerns

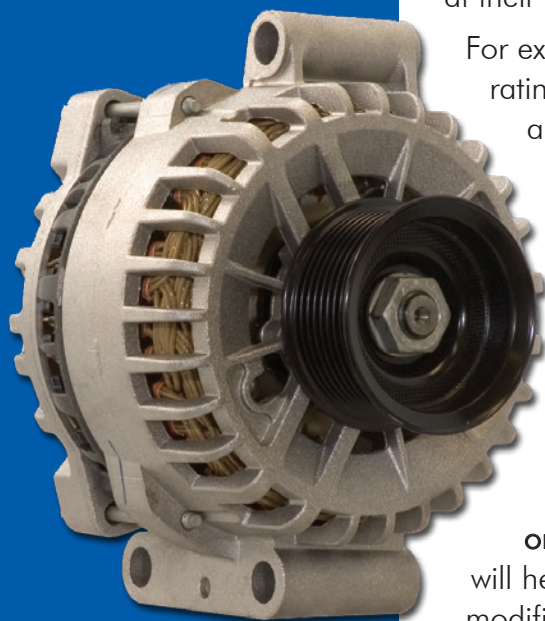
Ford 6.0L diesel trucks often experience low voltage for several minutes after start-up. As a result, many believe the unit is not charging. What's actually occurring, however, is the amperage demands of the vehicle are exceeding the capabilities of the alternator, which is supplying the vehicle's electrical demands. A simple upgrade to the Remy 92570 alternator can reduce or eliminate low voltage concerns and solve your problem.

A simple upgrade to the Remy 92570 alternator can reduce or eliminate low voltage concerns.
