# Troubleshooting guide

# Lambda Sensors

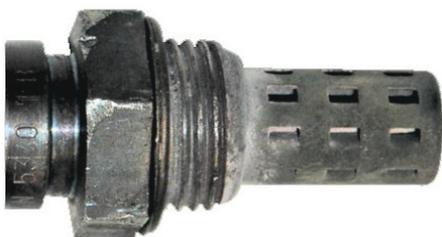
### Normal

Sensor is free of any residue, and is dull in colour.

**Cause:** Clean engine burning as a result of proper preventative engine maintenance.

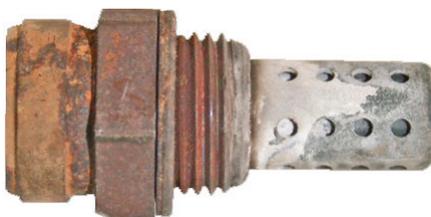
### Antifreeze contamination

Excessive grainy white-grey colour, sometimes greenish deposits.

**Cause:** Contamination due to the presence of coolant fluid in the engine cylinders.

**Solution:** Check the engine coolant system, especially the head gasket, for leakage and repair if required. Replace the sensor.

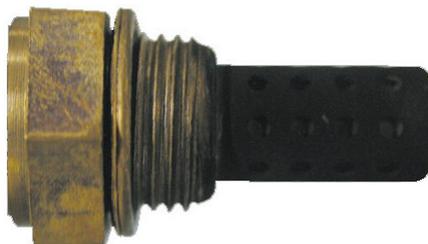
### Oil contamination

Excessive dark grey / black deposits.

**Cause:** Contamination due to excessive oil consumption.

**Solution:** Check the engine for oil leakage or wear, and repair if required.

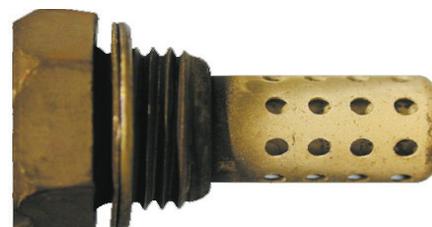
### Additive contamination

Excessive red or white deposits.

**Cause:** Contamination due to use of excessive or harmful additives. Certain ingredients of fuel additives can contaminate the Sensor element. When burned in the engine, they cause fumes that will contaminate and/or clog the sensor element.

**Solution:** Clean the engine and/or fuel system to remove the additives. Replace the sensor.

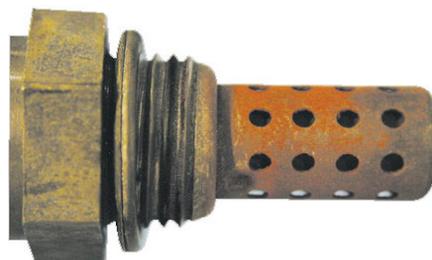
### Lead contamination

Shiny, dark grey deposits.

**Cause:** Contamination due to use of leaded fuel. Lead attacks the platinum which is present both on the sensor element and in the catalyst.

**Solution:** Remove the leaded fuel from the vehicle, and refill with lead-free fuel. Replace the sensor.
