Troubleshooting guide

Lambda Sensors

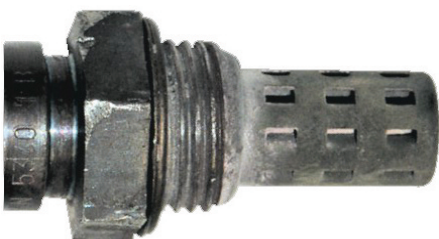
Normal

Sensor is free of any residue, and is dull in colour.

Cause: Clean engine burning as a result of proper preventative engine maintenance.
