Vehicle Applications for Remy Part 92570

Remy Upgrade Helps Solve 6.0L Ford Low Voltage Concerns

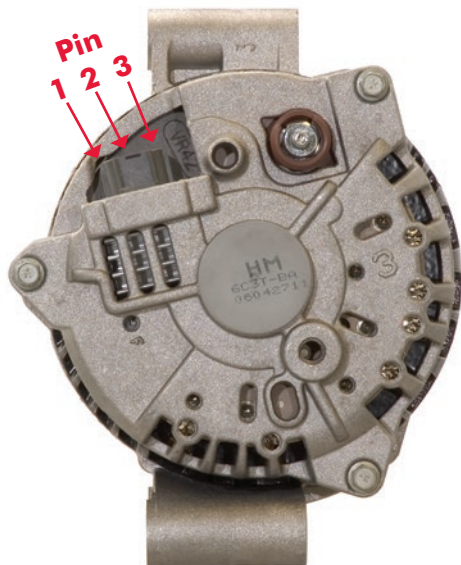
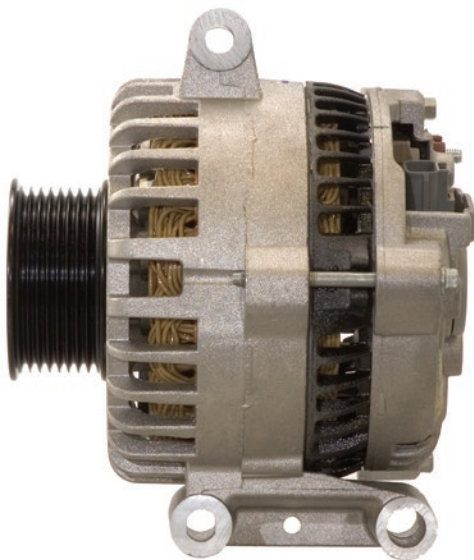
A simple upgrade to the Remy 92570 alternator can reduce or eliminate low voltage concerns.

There is a simple replacement solution that will help the vehicle with no additional modifications required. **Remy 92570 alternator produces 140 amps and is interchangeable with the original unit.** Replacing the original 110-amp unit with the 92570 will help support vehicle demands without requiring bracket or wiring modifications. *(Note: Increasing amperage much beyond 140 amps would require a larger gauge B+ wire to safely support the additional current flow.)*
