**Addressing Subaru Vibration Issues**

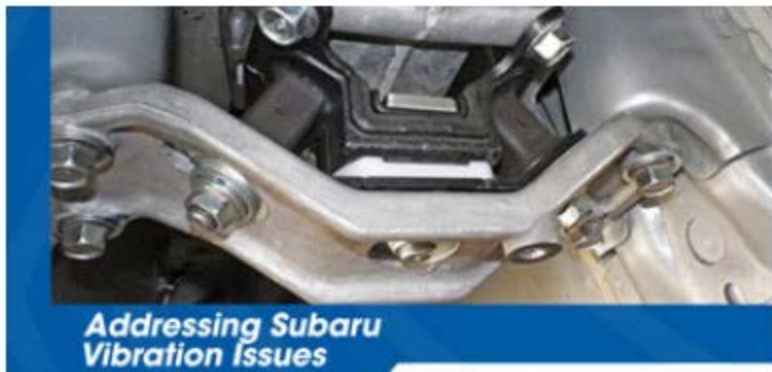
*Subaru transmission mounts are susceptible to becoming very spongy and wear out due to the unique horizontal movement of a boxer (cylinders horizontally opposed engine. When these mounts wear, they cause the engine/transmission to sit slightly off center.*

**SOLUTION:** *Inspect and replace the transmission mount (if worn) to eliminate off center vibration issues. Note: if the mount is worn, the articulation angle of the new replacement axle becomes the mount that is holding the transmission in the correct location, which creates a binding vibration*
